Property ID:	1299
Property Address:	3537 St. Paul
Owner:	Claron Taylor
Phone:	303.733.9017 or 303.321.9137

**U.S. Environmental Protection Agency
Vasquez Boulevard I/70 Superfund Site
Replacement Certificate**

This spreadsheet performs screening level calculations to estimate the effect of peeling leaded paint on the average concentration of lead in yard soil
3537 St. Paul St.

SITE NAME: VASQUEZ BOULEVARD AND I-70

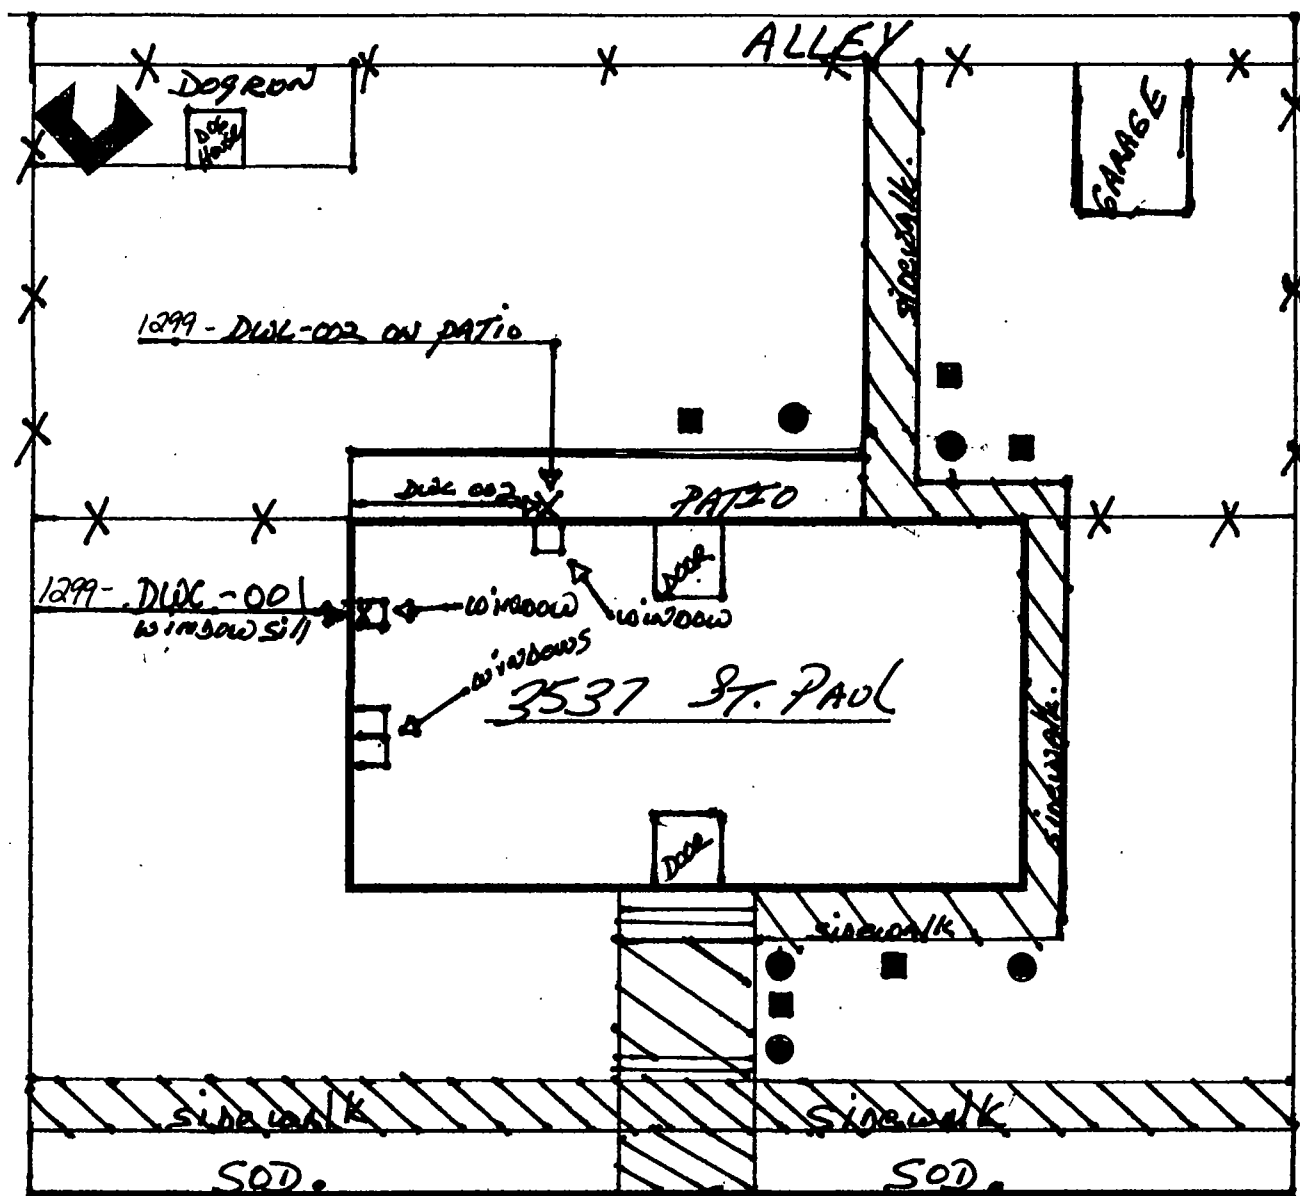
3537 St. Paul St

A hand-drawn diagram of a garage layout. The diagram shows a rectangular area labeled "garage (no deter paint)". To the left of the garage is a horizontal line labeled "Fence". The distance from the fence to the top of the garage is marked as 20'1" with a double-headed arrow. The distance from the fence to the bottom of the garage is marked as 6' with a double-headed arrow. The width of the garage is marked as 12'4" with a double-headed arrow. The distance from the right side of the garage to the right edge of the page is marked as 3' with a double-headed arrow. There are two black circles at the top of the diagram, one on the fence line and one on the garage roof line.

- 1) N. →
- 2) ► DWOC-001-1299/5:45
- 3) ► DWOC-002-1299/5:55
- 4) ● SCC-001-1299/6:00 1' offset
- 5) ■ SCC-002-1299/6:20 1' offset
- 6) 10-24-05
